DATE OF DOC	DATE REC'D	DATE OUT	SUSPENSE DATE	CROSS REFERENCE OR POINT OF FILING
	30 JULY 64			
TO FROM SUBJ. DD32000X A-1H Aircraft Accident.				ROUTING
CY 1 CNO 2 D/Tech * * * Col. G... " " "				DATE SENT
COURIER NO.	ANSWERED	NO REPLY	4

OX CART SECRET**A. History of Flight**

On 9 July 1964 Lockheed test pilot [REDACTED] was scheduled in A-12 Aircraft number 133 for a maximum A/B climb to Mach 2.8 and sustained flight at Mach 2.8 and 78,000 feet. Route to be flown was Copper Bravo route (Photo 4844). Weather was better than usual and was not a factor in this accident. Aircraft inspection and personal equipment hook-up was performed by qualified ground crews in accordance with flight handbook and organization procedures. Take-off at 0820 PDT was normal (210K and 7400 feet ground roll with aircraft weight 112,000 pounds). An F-101, No. 312, piloted by Col R. J. Holbury and Capt R. J. Roussell was to be used for chase within the capabilities of the aircraft. After take-off chase advised that number 133 was clean and smooth. Both aircraft checked in with Bungalow, who advised good IFF/SIF contact. [REDACTED] performed maximum A/B climb to 78,000 feet and 2.8 Mach. At the northern li

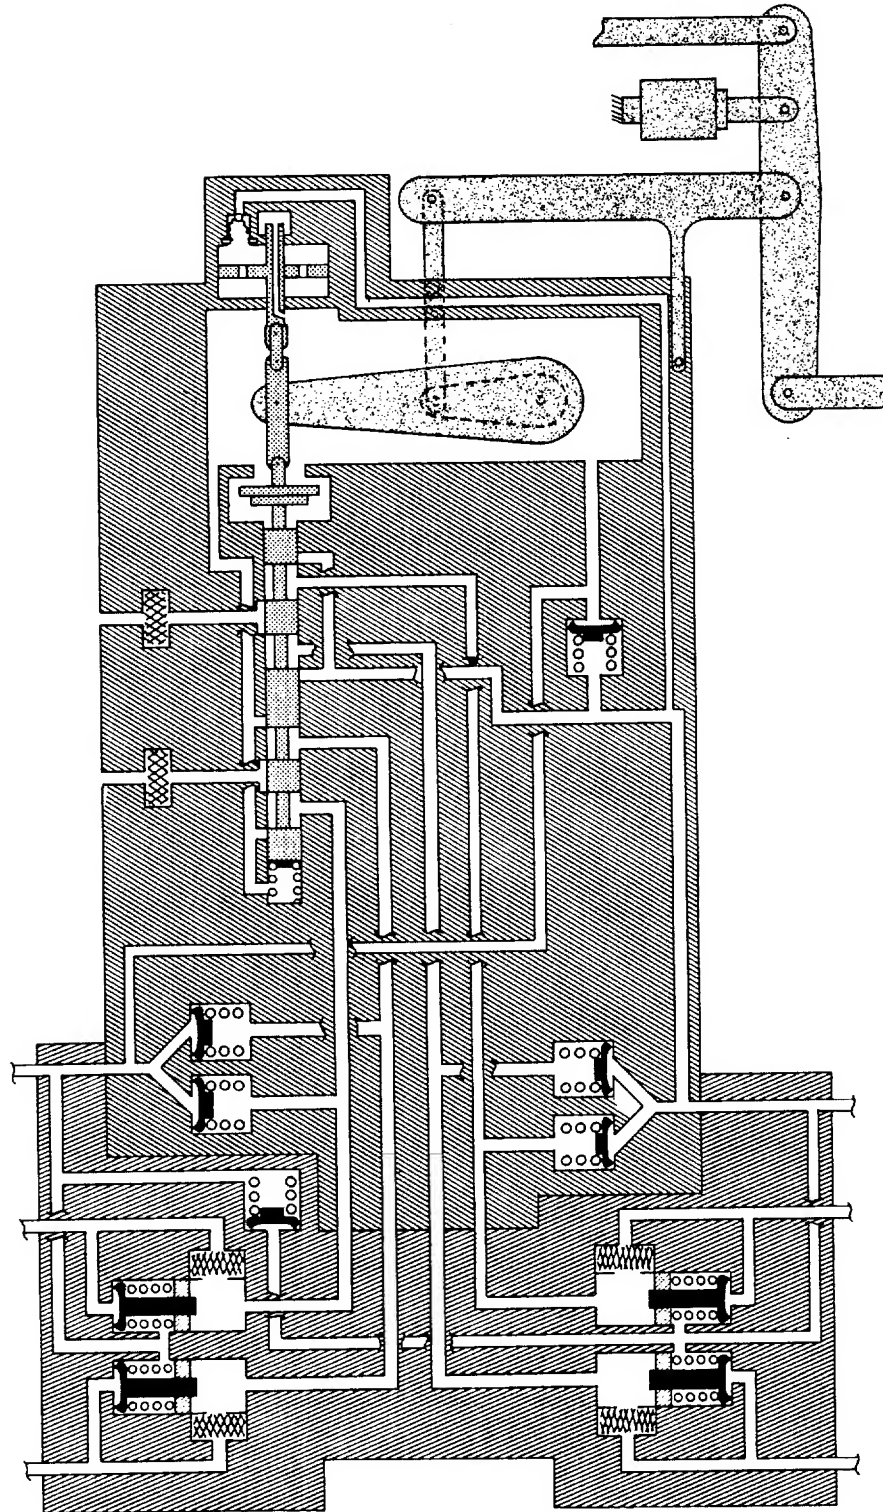
MAF12-2-7-3
SERVO - OUTBOARD ELEVEN
FIGURE 4

(1) Investigation revealed that the position of the right outboard elevon was full down on impact. Further investigation was then centered on determining how this condition could have occurred. The right outboard elevon servo valve was subjected to exhaustive tests at Lockheed-Burbank and it was determined that binding had definitely occurred. This particular valve apparently incurred warpage in operational use as evidenced by burnishing on the valve wall. The described warpage caused the valve to bind but not to a degree that would prevent the elevon mechanical transmission system from overcoming it. However, oil samples revealed contamination within the servo valves, probably the result of metal chips accumulated during manufacture. This contamination would add to the drag caused by warpage. Additionally it was concluded that because of a rapid change in flight conditions, the valve was subjected to a temperature shock condition that further aggravated the warpage. From the foregoing it was concluded that the metering spool in the right outboard elevon servo did bind to such a degree that it could

1. The primary cause of this accident was that the outboard elevon servo valve stuck in the partially open position causing the right outboard elevon to gradually move to the full down position. This imparted more left roll to the aircraft than could be overcome by the pilot. The sticking of this valve resulted from the combination of three conditions; warpage of the valve incurred in operational use, a temperature shock condition due to a rapid change in flight conditions and metal particles within the servo valve probably accumulated during manufacture.
